Innovation Week on “PV Systems Engineering and the other Renewable Energy Systems”.

**Ageing effects in PV cells and
modules**

Dr E. Kaplani

Mechanical Engineering Dept.
T.E.I. of Patras, Greece

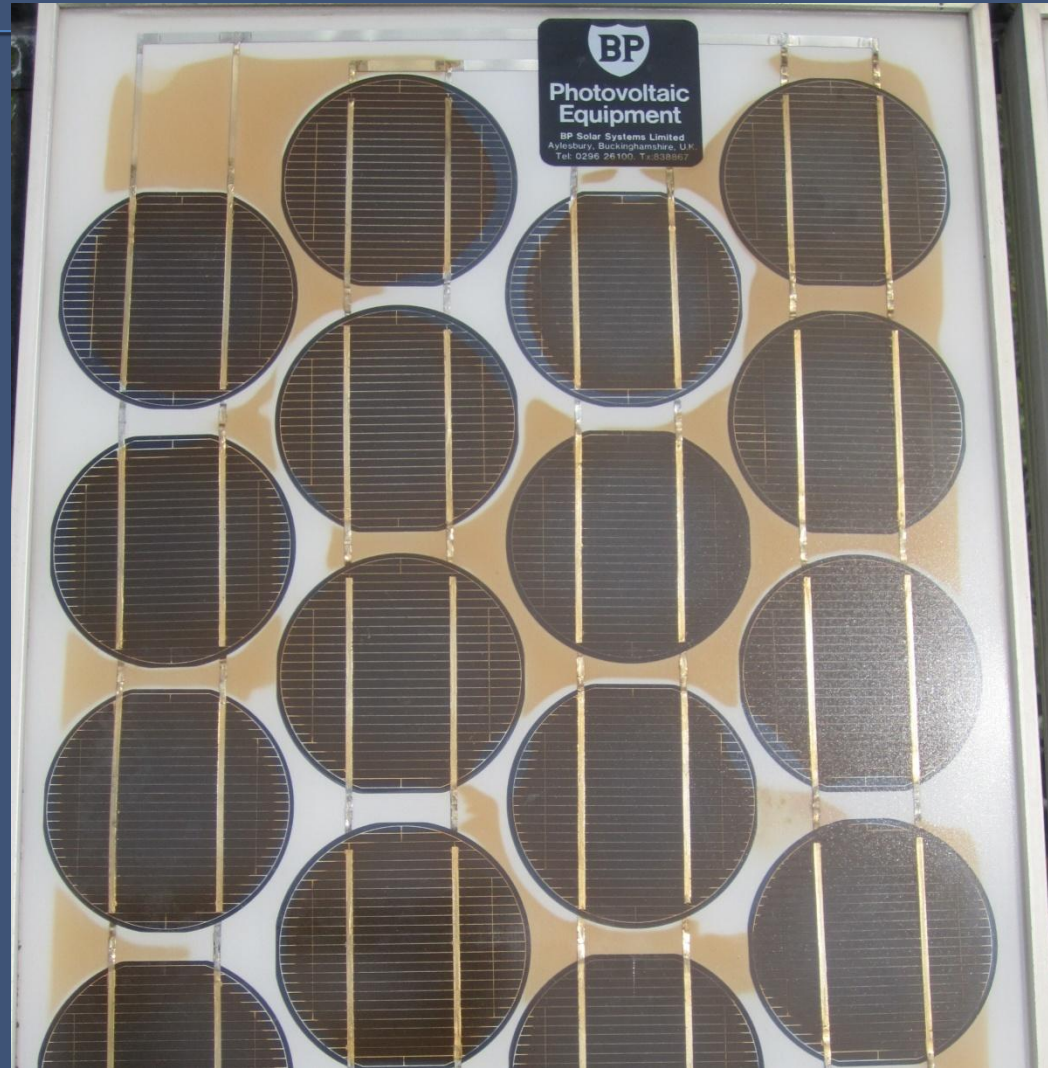
BP B 1233

EVA Discoloration

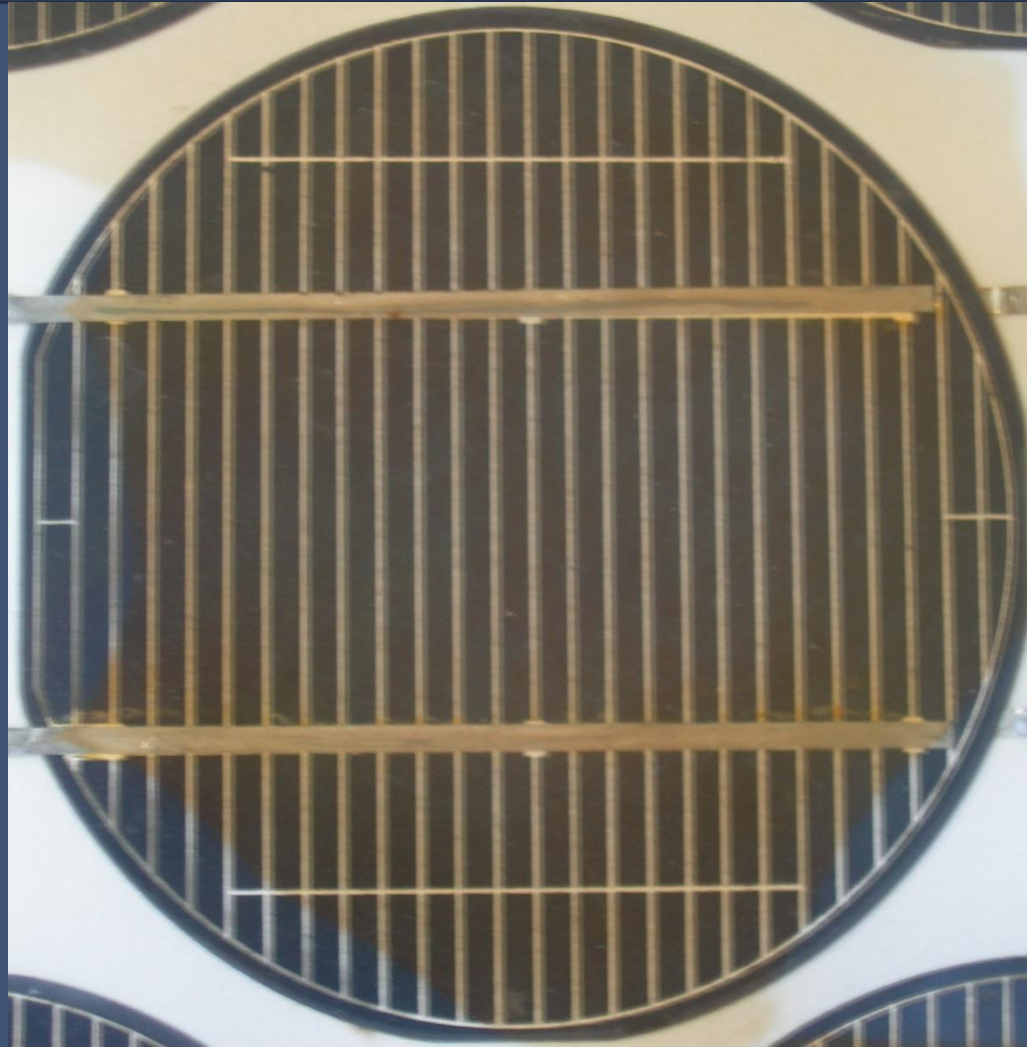
EVA Discoloration – BP B 1233

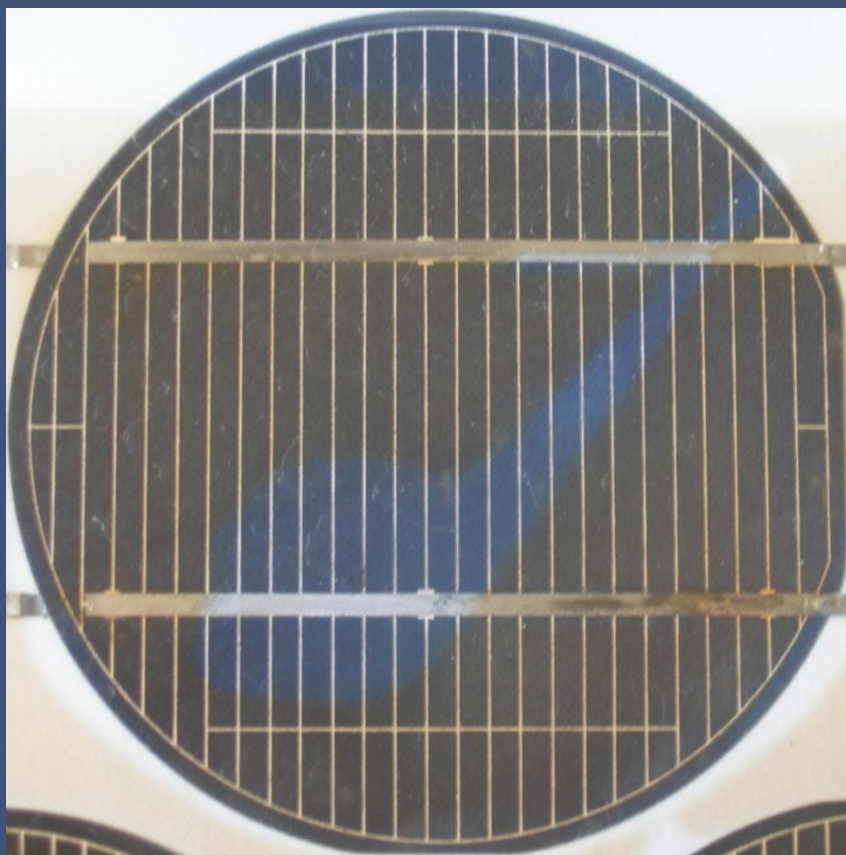
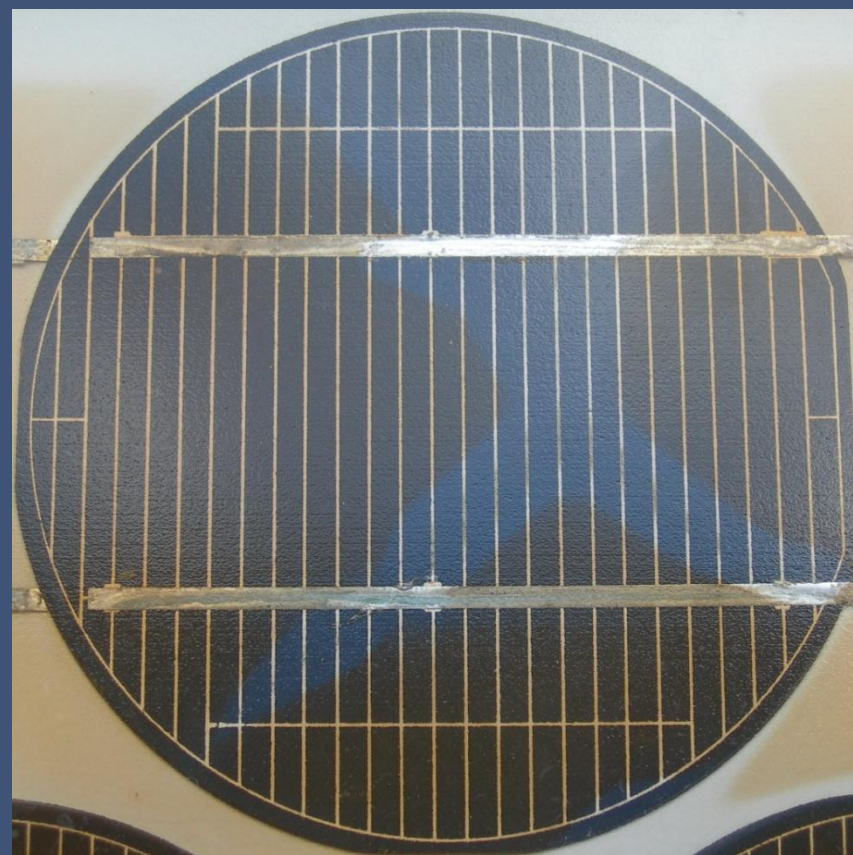
EVA Discoloration – BP 1233

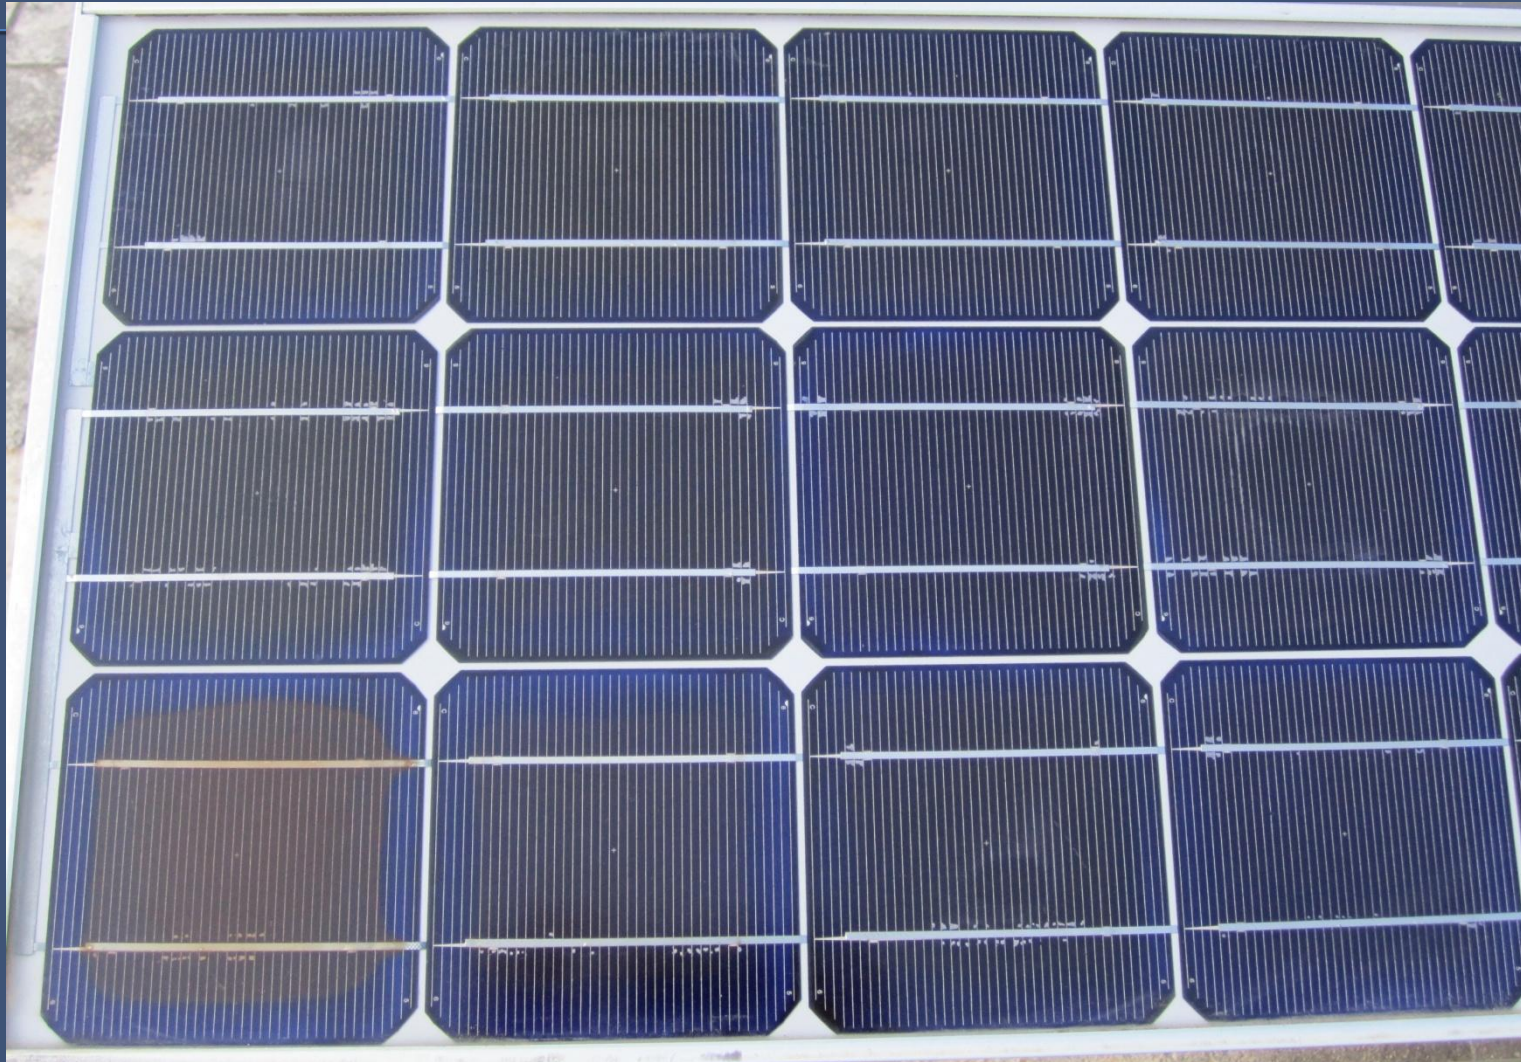
EVA Discoloration – M55

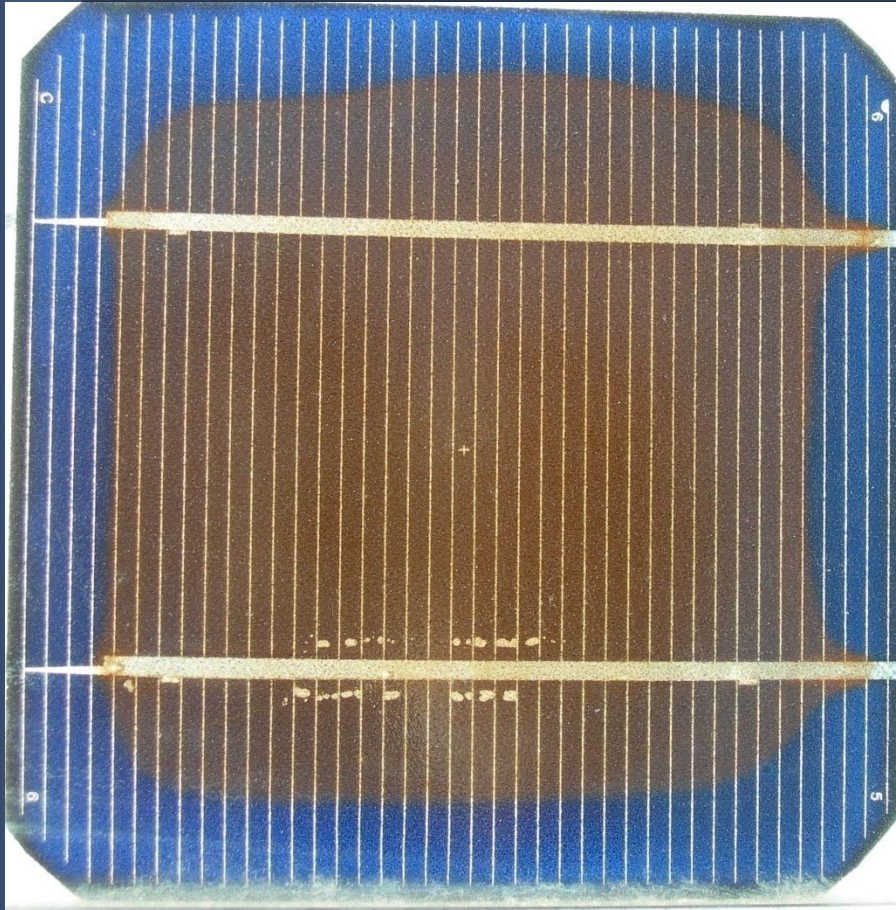
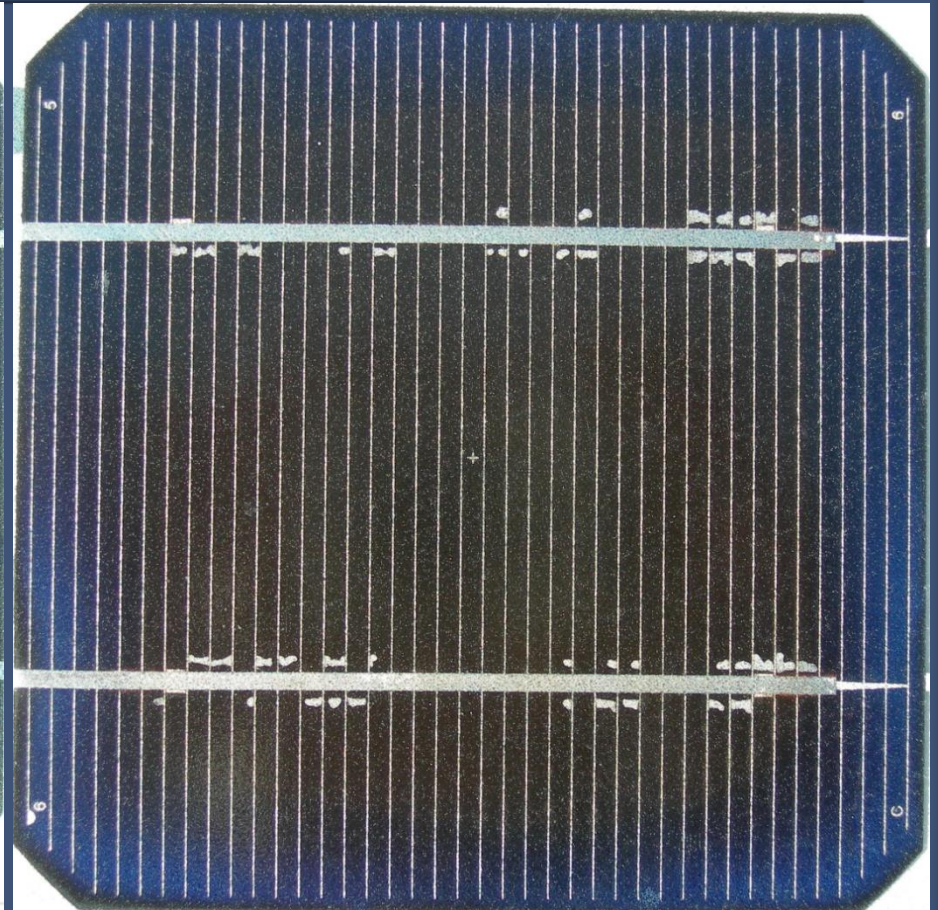
EVA Discoloration – M55

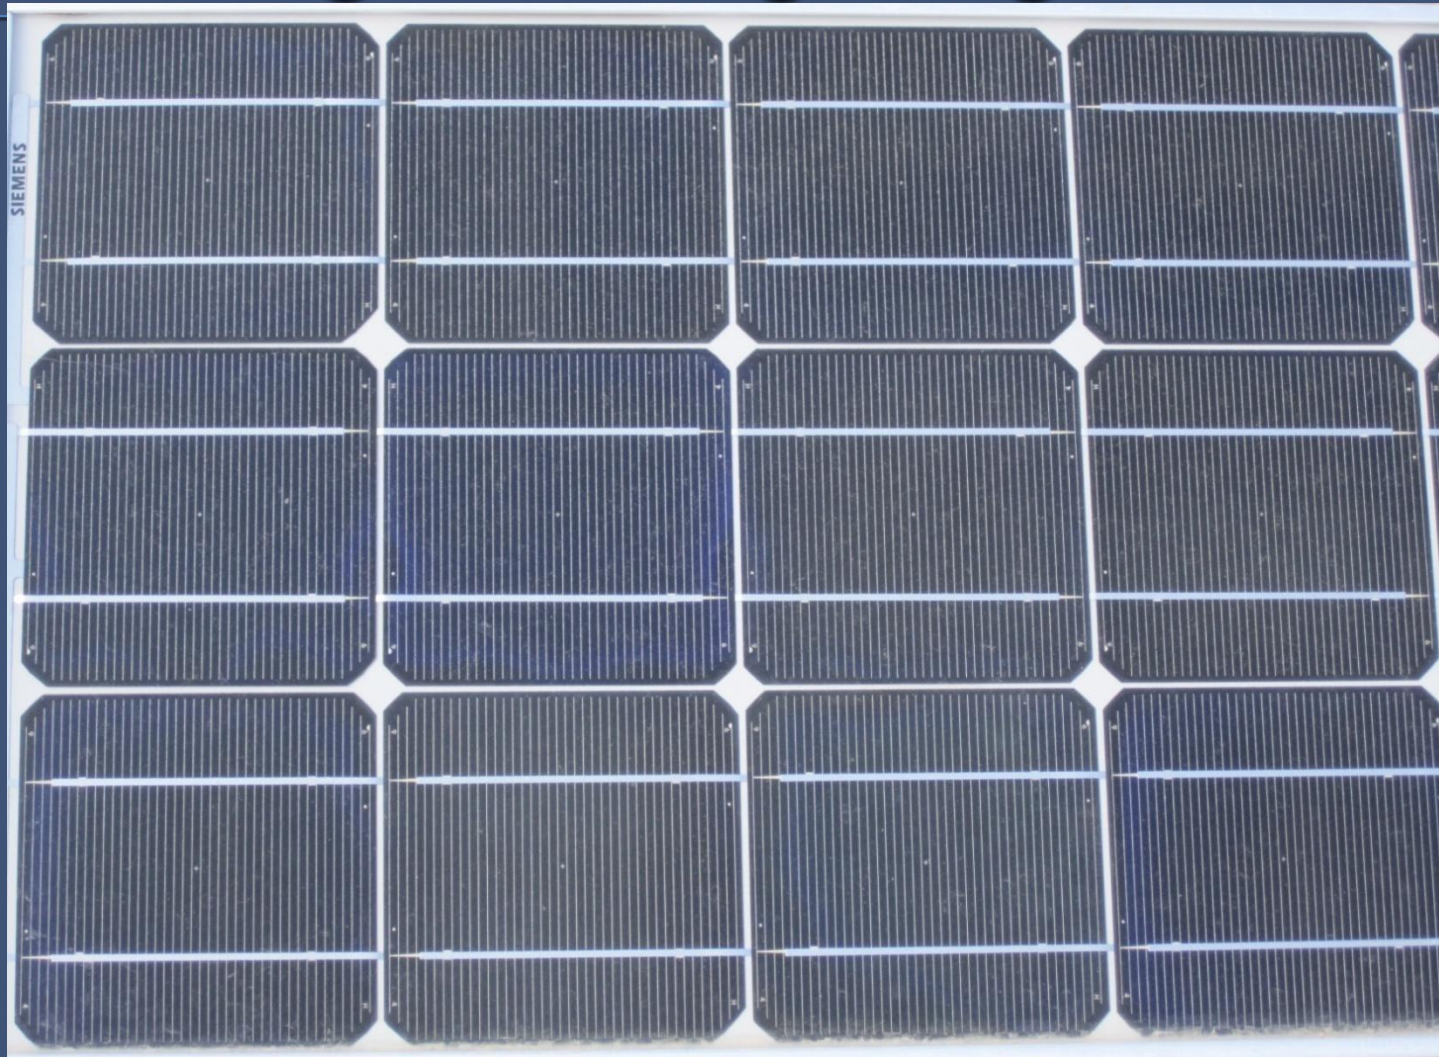
First signs of ageing – SM55

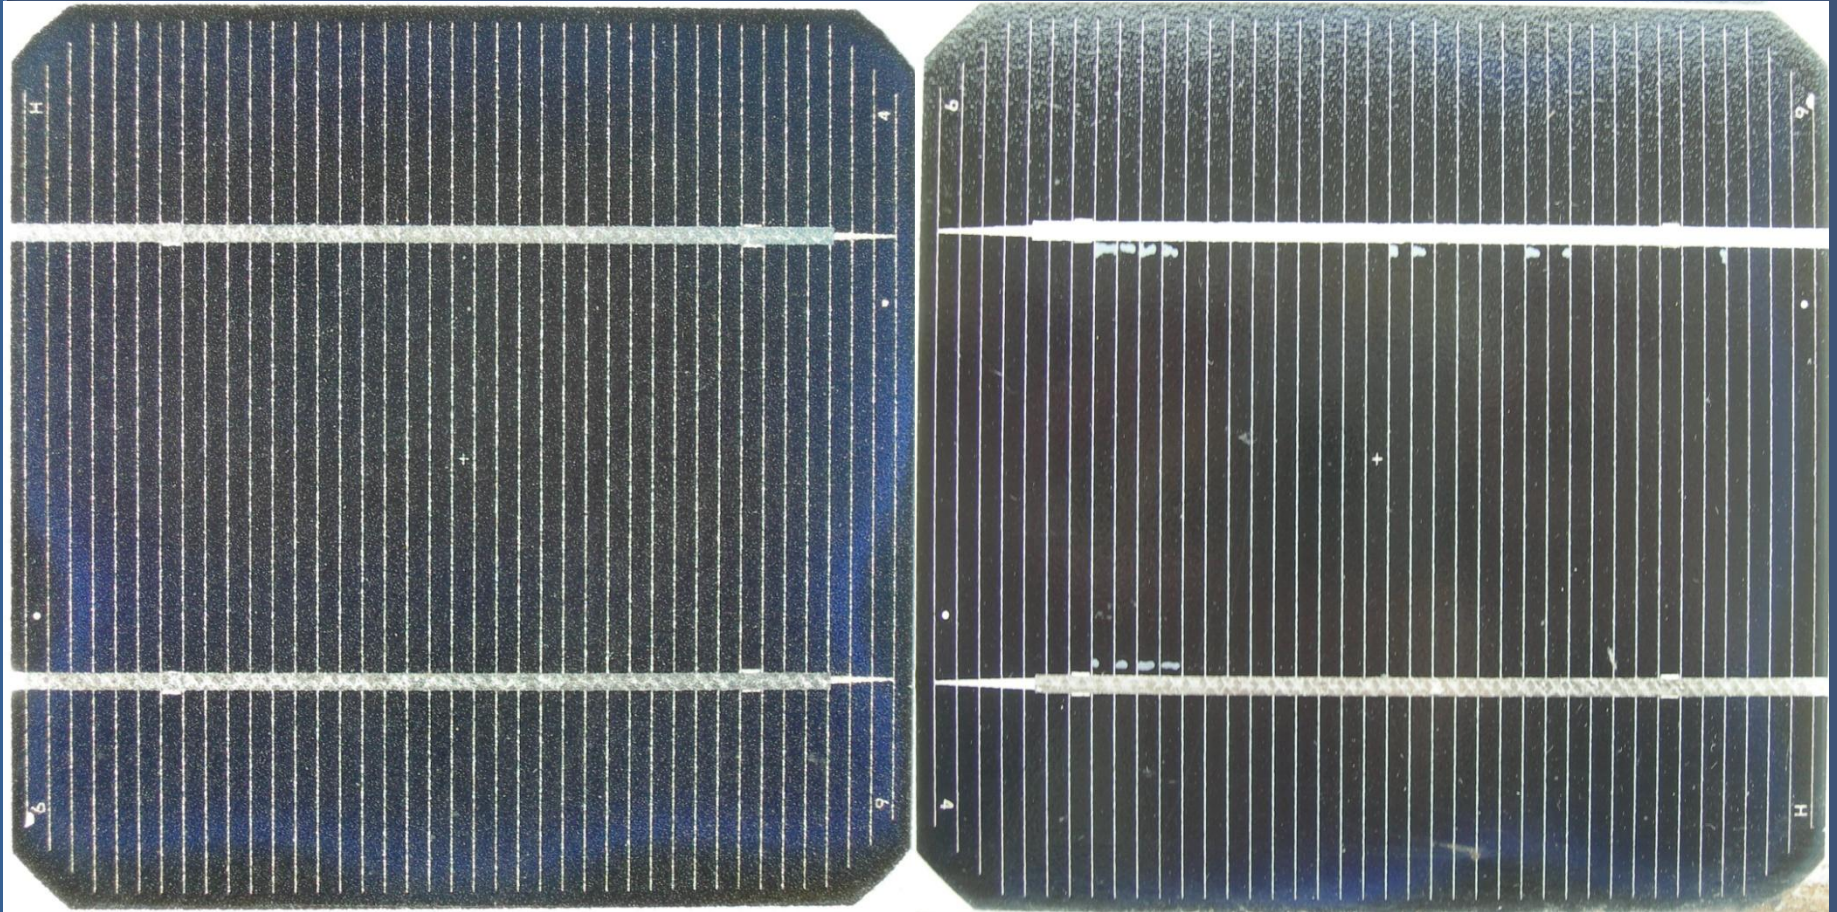
AR deterioration – SM55

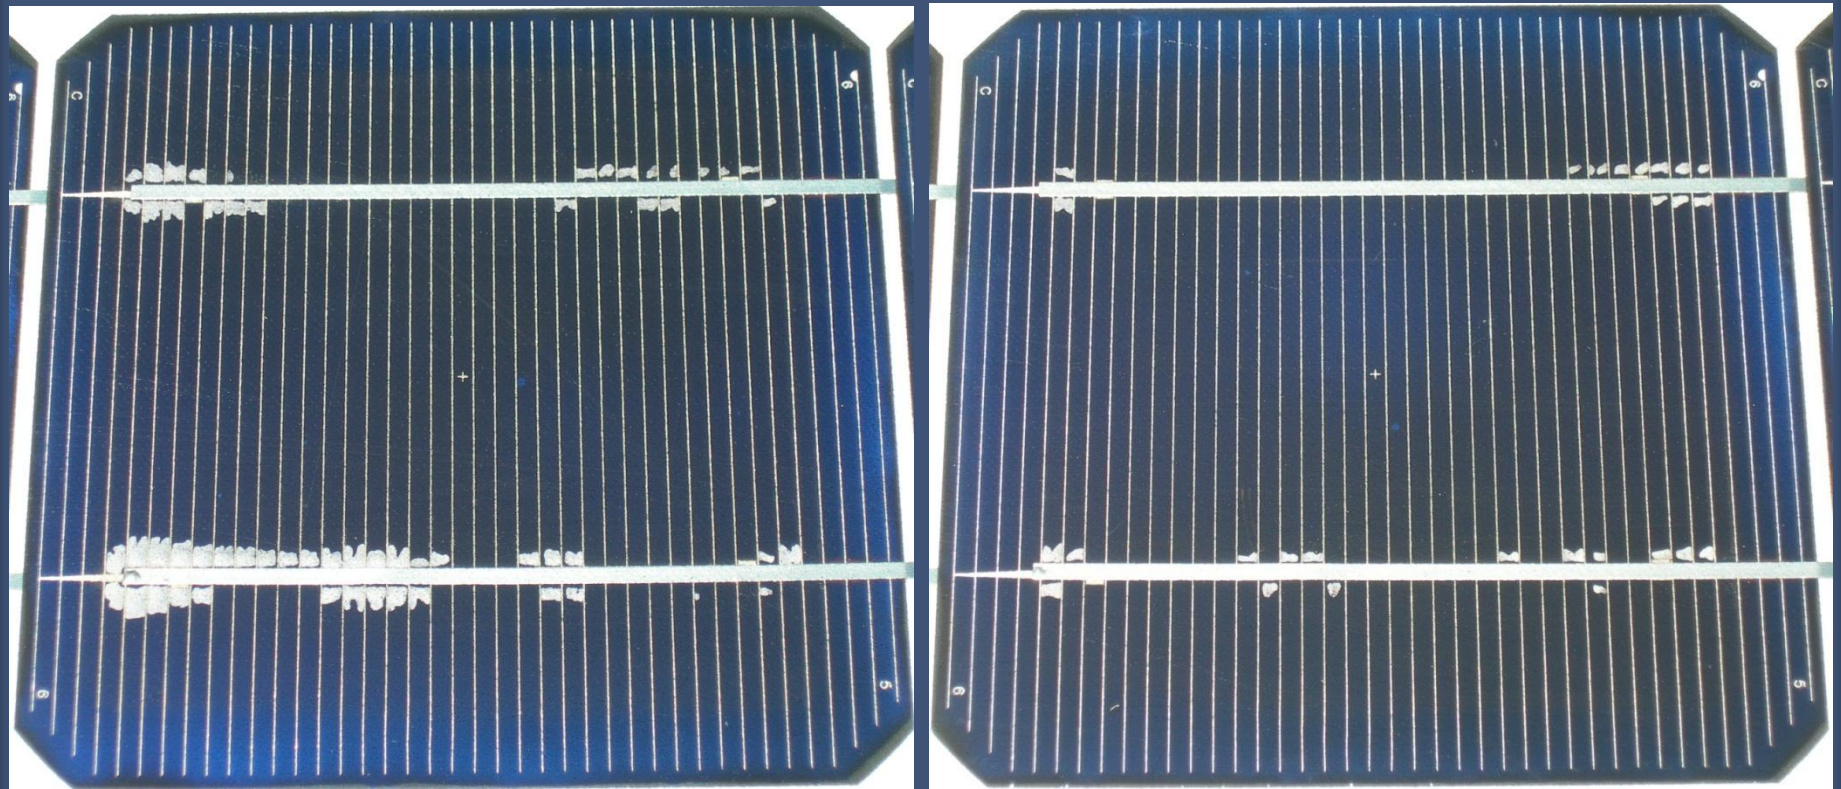
Delamination – M55

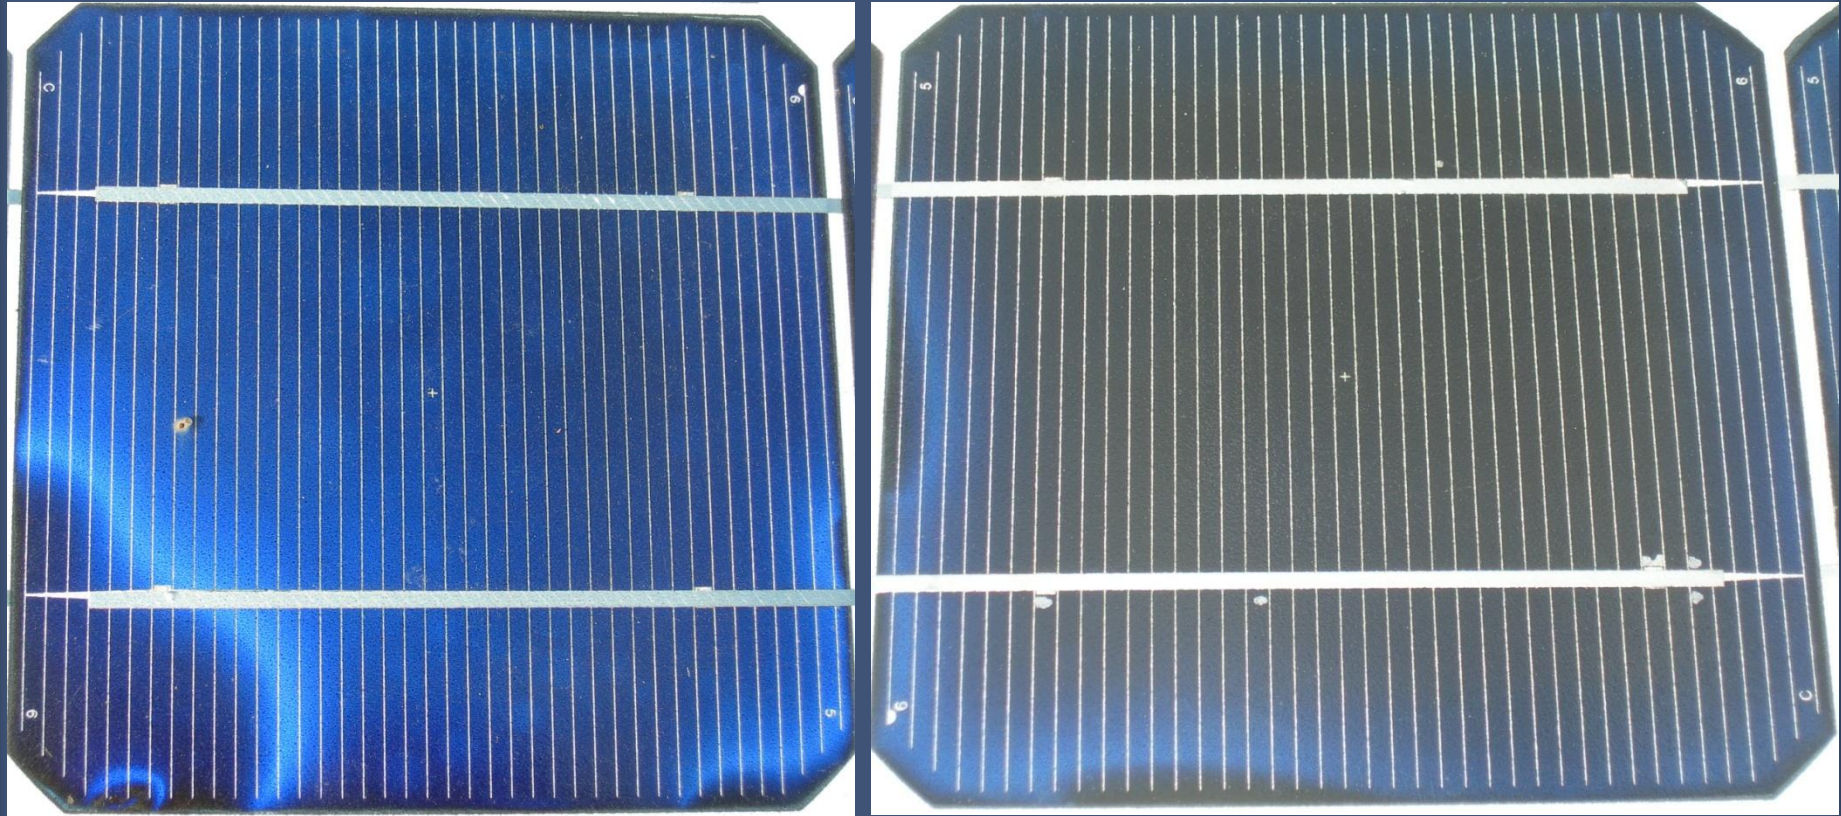
AR deterioration/oxidization – M55

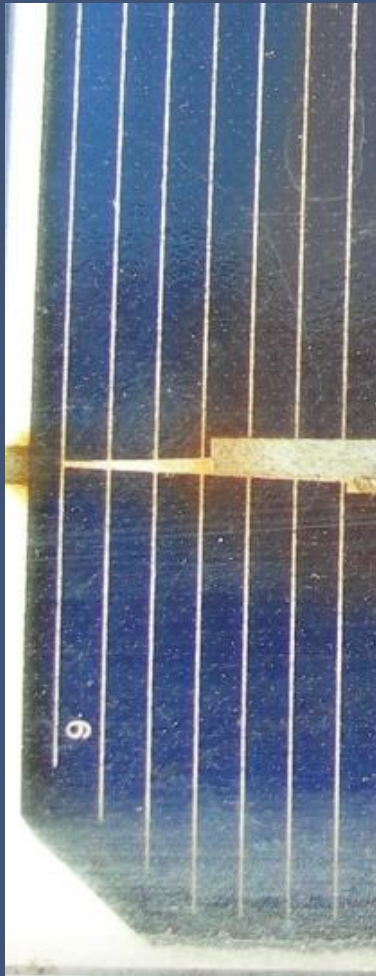
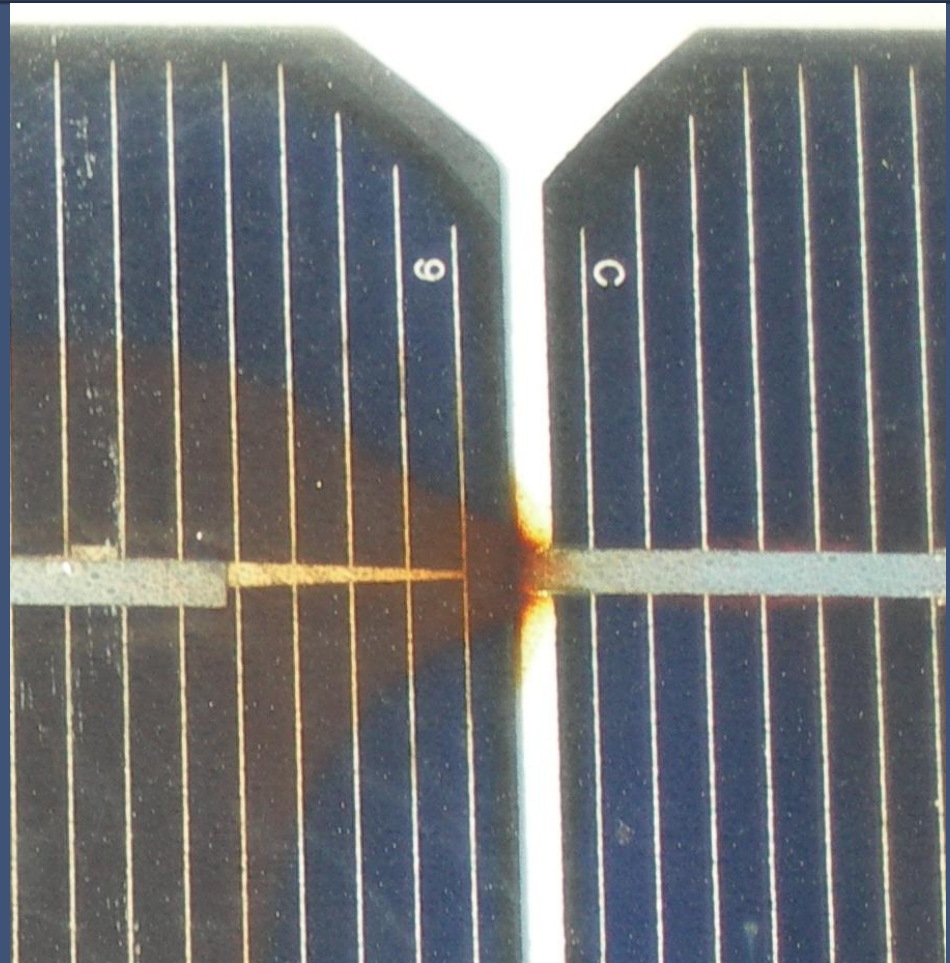
Corrosion of contacts – M55

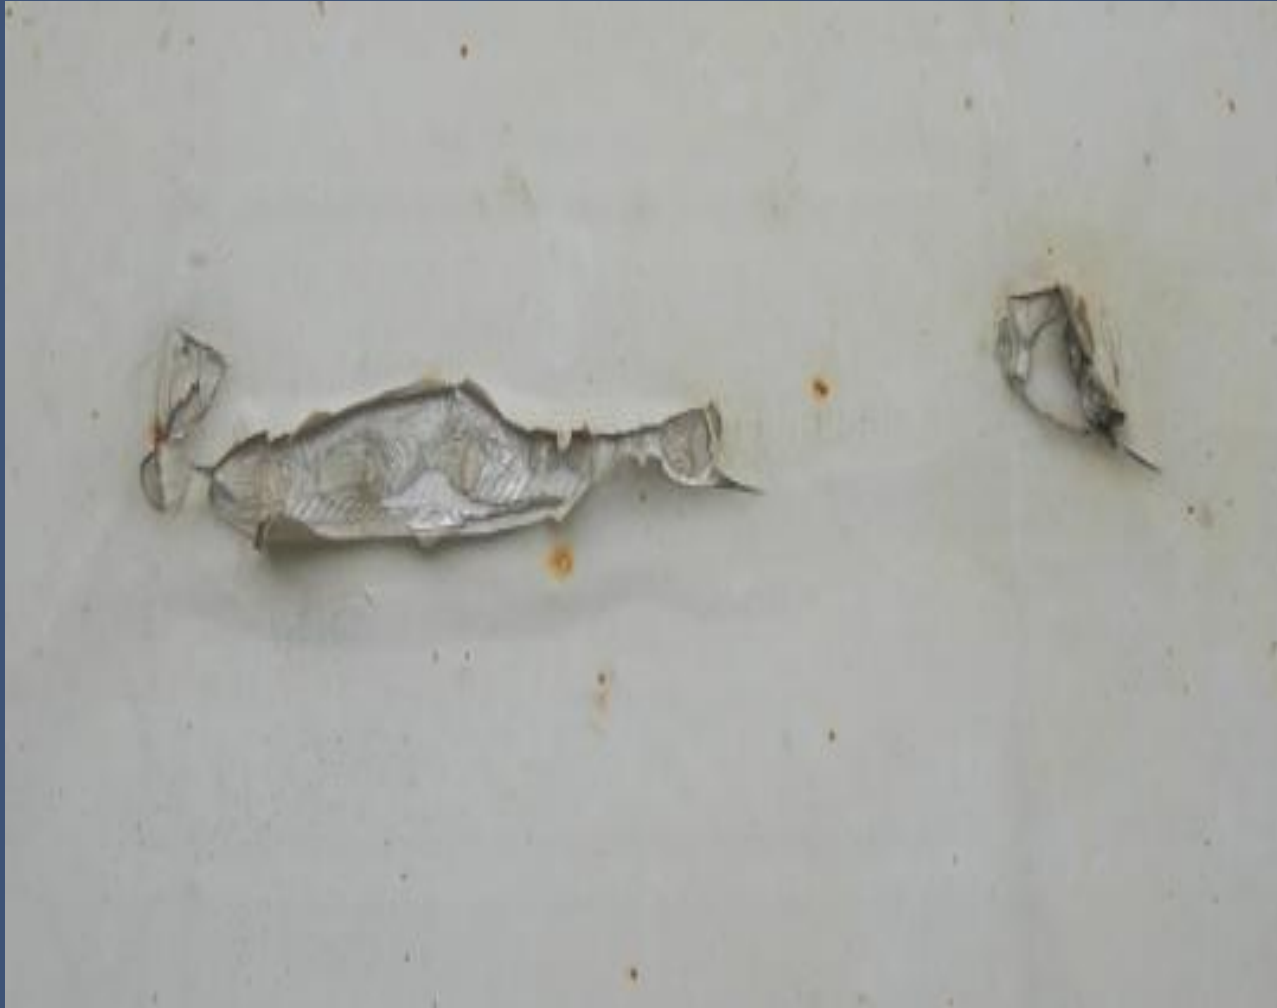
Damage in the back sealing – BP B 1233

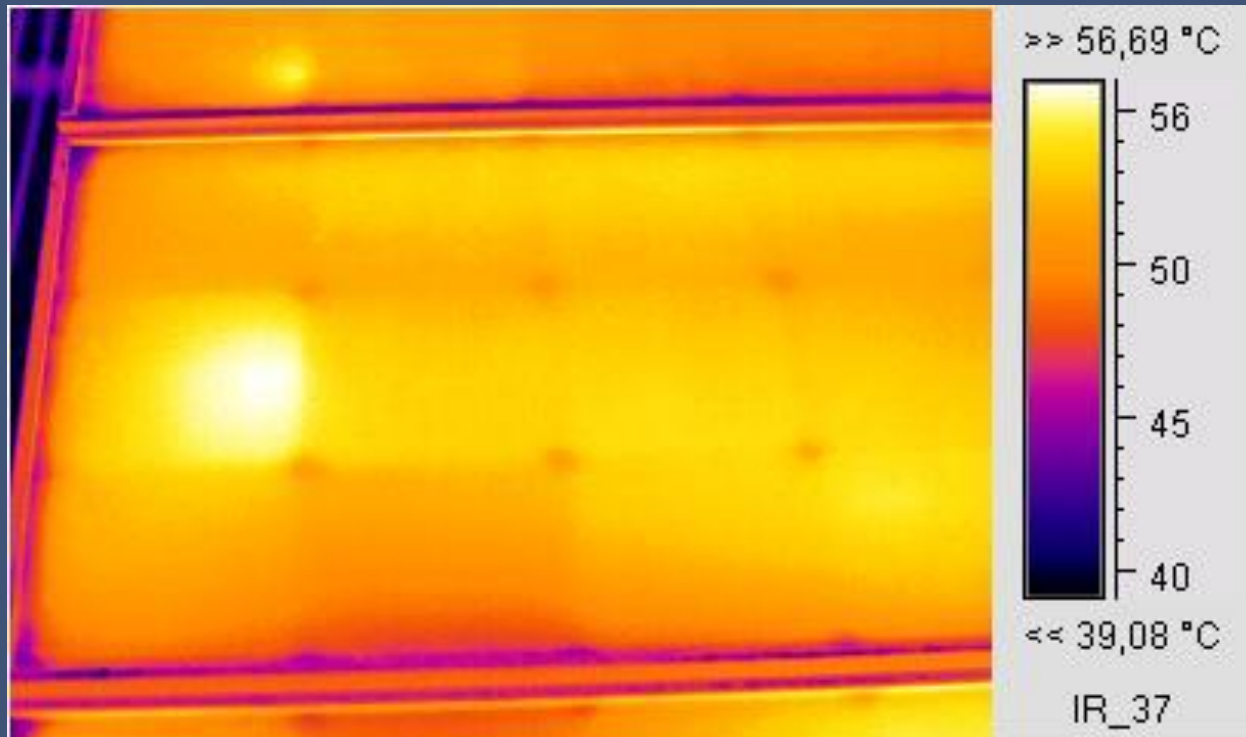
Junction box – M55

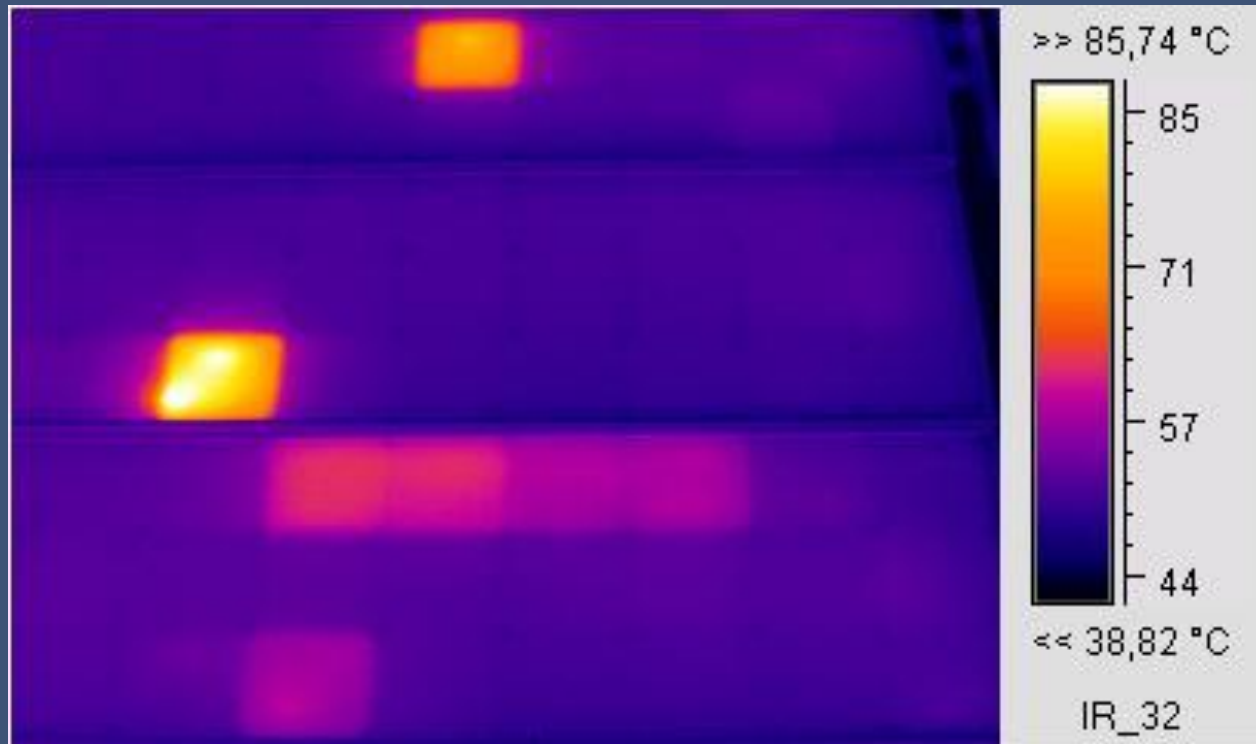
Hot spots/ hot areas – M55

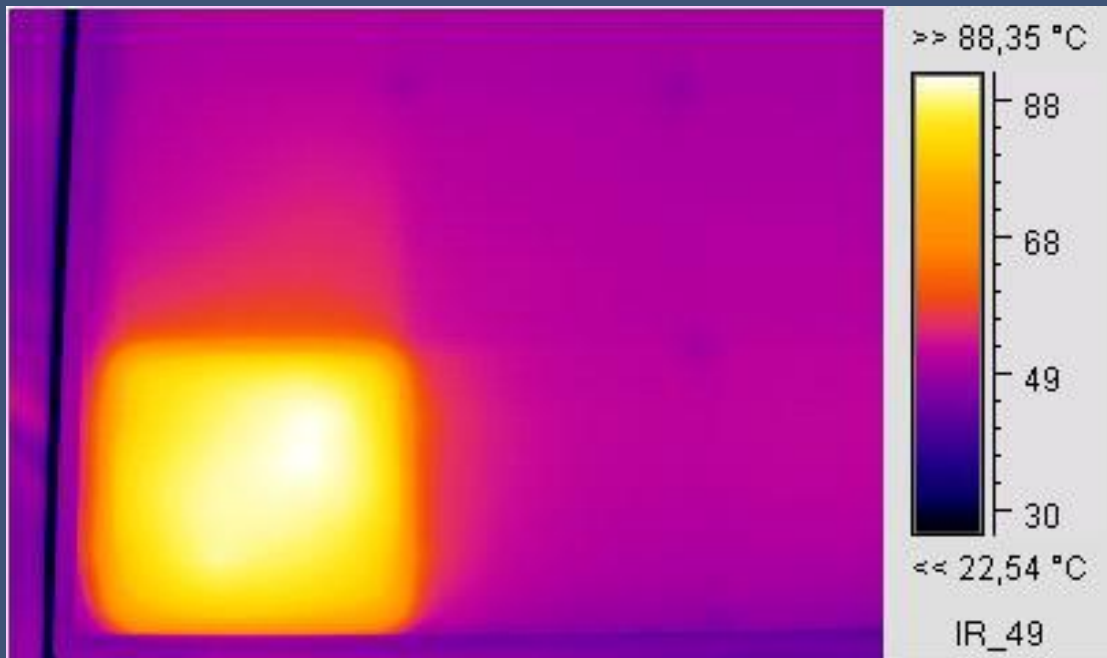
Hot spots/ hot areas – M55

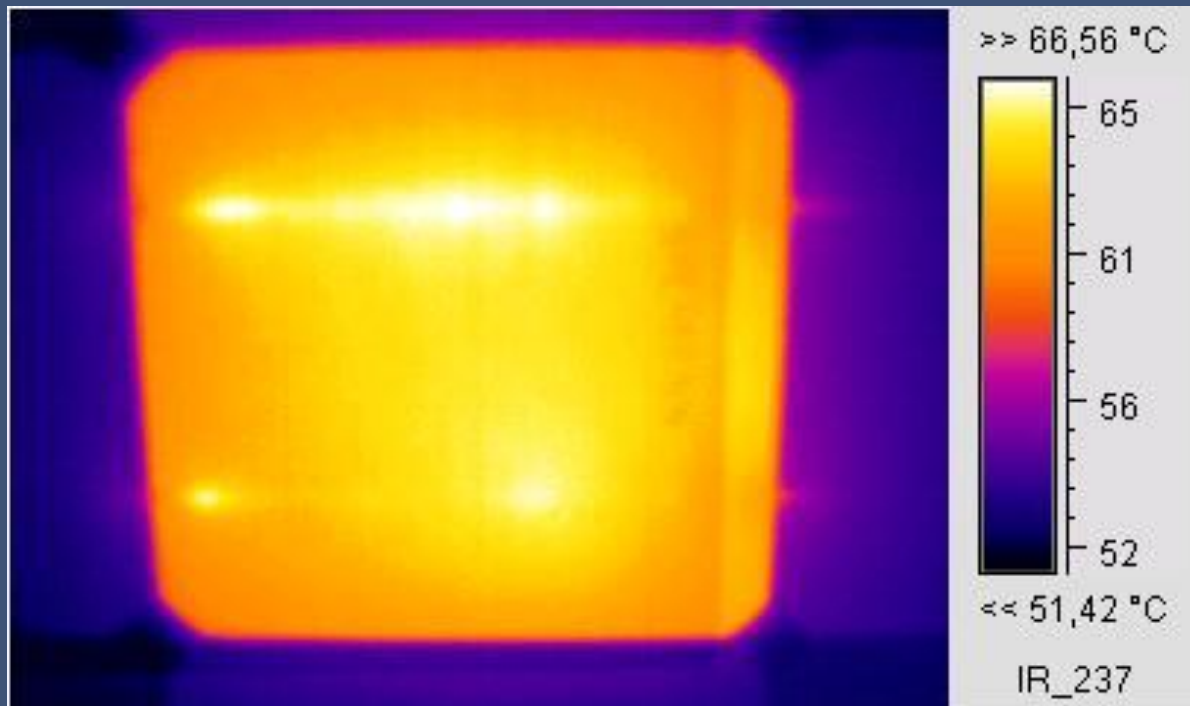
Hot zones at bus bars – M55

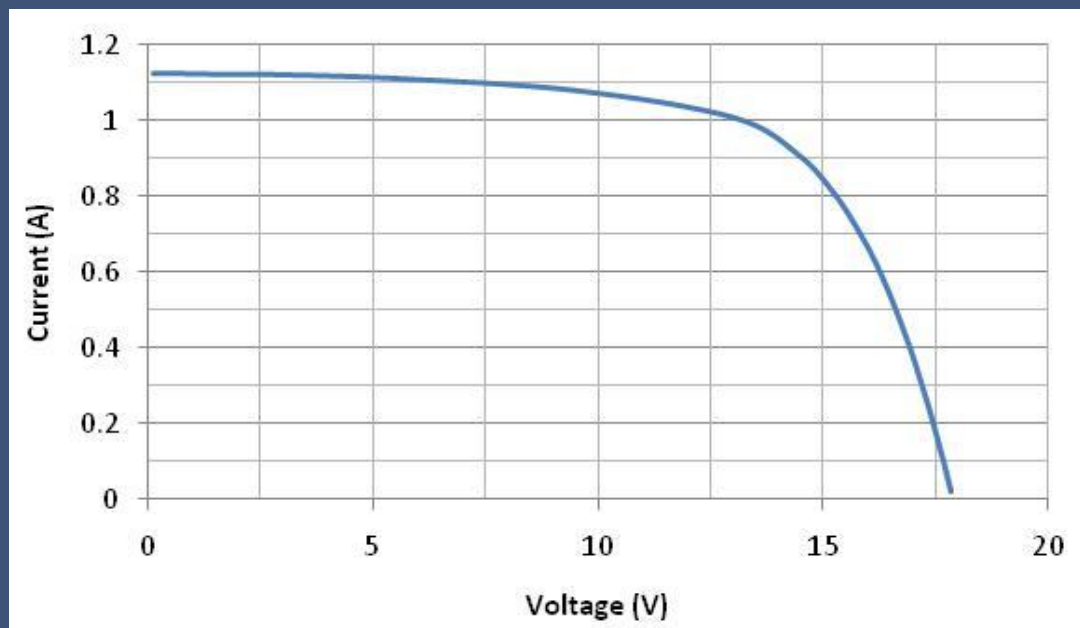
- BP B 1233

Nominal	BP B 1233
Isc	2.3
Voc	20
Pm	33
Im	2
Vm	16.5
FF	0.717

$$I_T = 482.7 \text{ W/m}^2, T_c = 39.8^\circ\text{C}$$

module	$\frac{P_m(STC)}{W_p}$	$\frac{P'_m(STC)}{W_p}$	FF(STC)	FF'(STC)	$\frac{P_m(STC) - P'_m(STC)}{P_m(STC)}$	$\frac{FF(STC) - FF'(STC)}{FF(STC)}$
M55	53	44.56	0.729	0.619	15.9%	15.1%
BP B1233	33	29.67	0.717	0.666	10.1%	7.1%

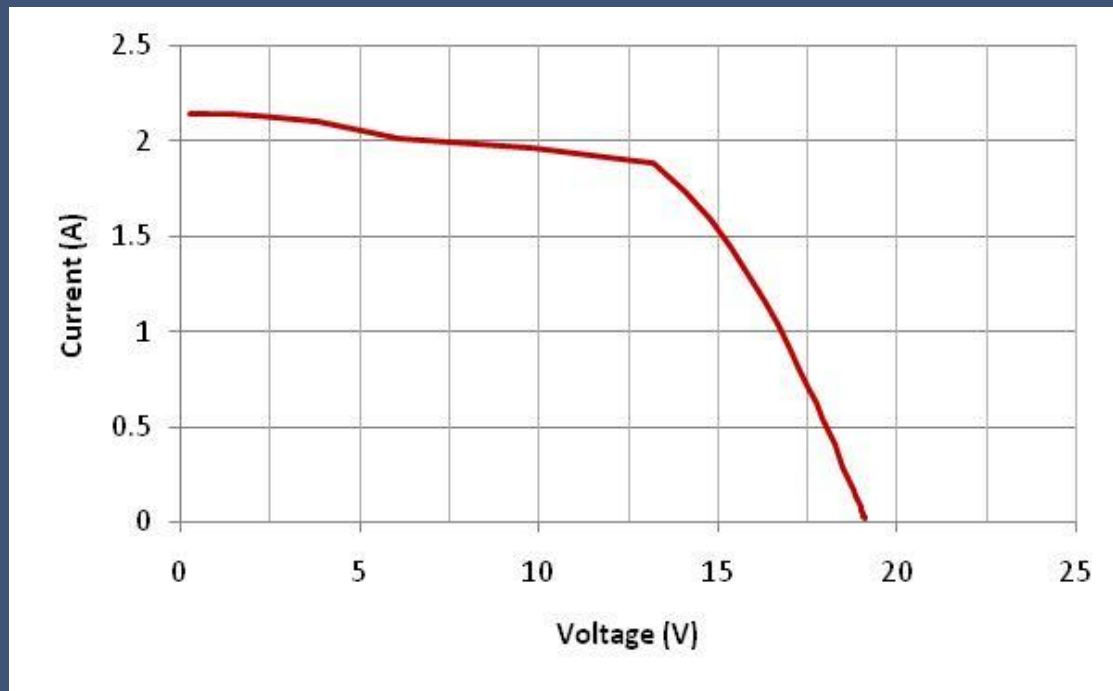
- M55

Nominal	M55
Isc	3.35
Voc	21.7
Pm	53
Im	3.05
Vm	17.4
FF	0.729

$I_T=617 \text{ W/m}^2, T_c=47.8^\circ\text{C}$
