Innovation Week on “PV Systems Engineering and the other Renewable Energy Systems”.

PV cell and module degradation

Dr E. Kaplani

**Mechanical Engineering Dept.
T.E.I. of Patras, Greece**

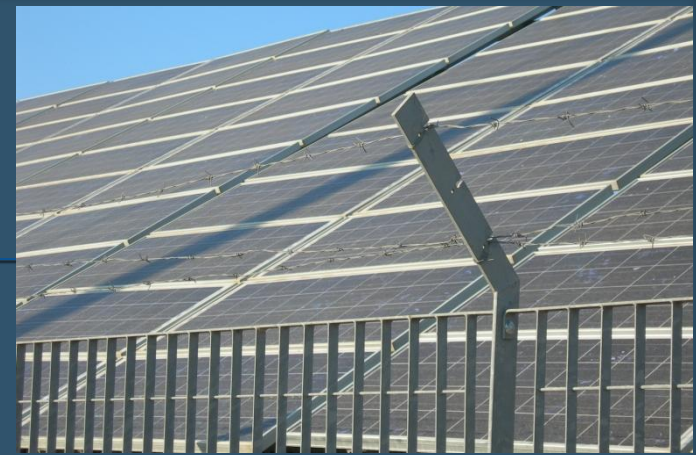
Long Term
Optical &
Physical
degradation

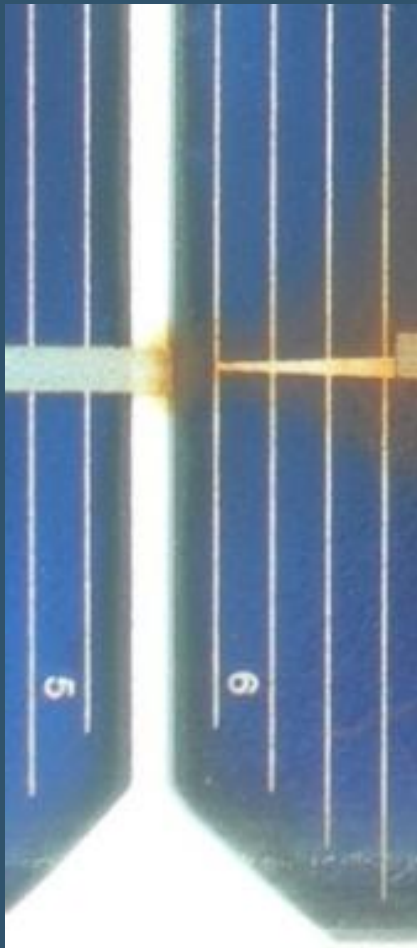
Corrosion of busbars and contacts

◎ Corrosion of contacts and busbars

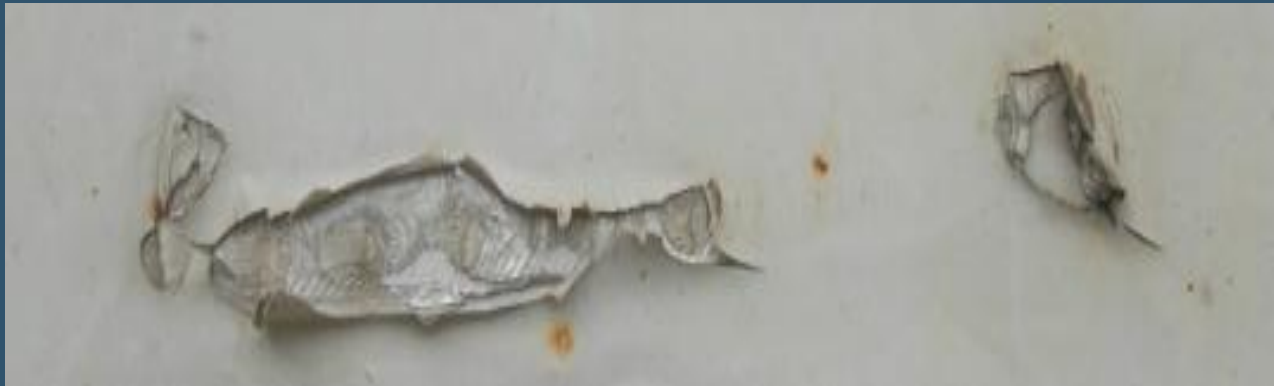
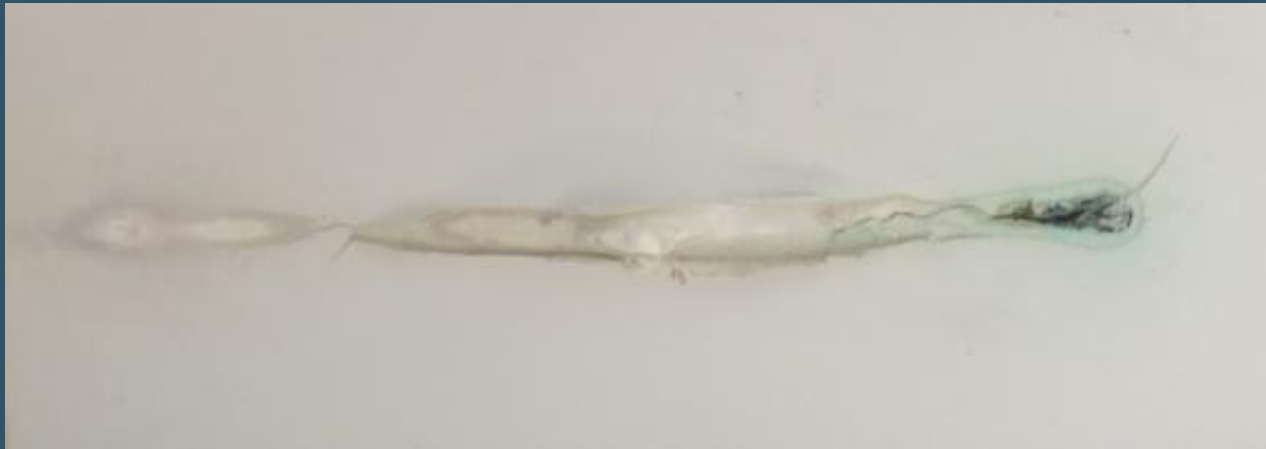
Damage in the back sealing

◎ Tears in the back sealing surface
