Innovation Week on “PV Systems Engineering and the other Renewable Energy Systems”.

**Ageing effects in PV cells and
modules**

Dr E. Kaplani

Mechanical Engineering Dept.
T.E.I. of Patras, Greece

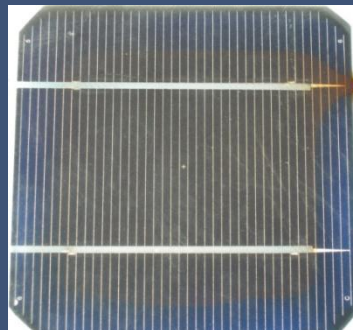
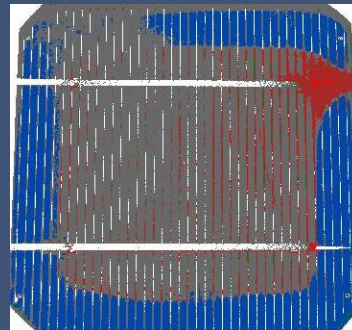
- The I-V curve analysis assists in the identification of the existence of critical defects in cell(s) in a module. It also provides an estimate of the performance degradation of the PV module $\delta P_m/P_m$, $\delta FF/FF$, R_s , R_{sh} .
- The IR thermography assists in the identification of the exact location and type of defect.
- Current work is involved in the identification of defects through digital image processing.
