# Diagnostics of photovoltaic power plants operation

**Vitezslav Benda,**  
CTU Prague, Faculty of Electrical Engineering

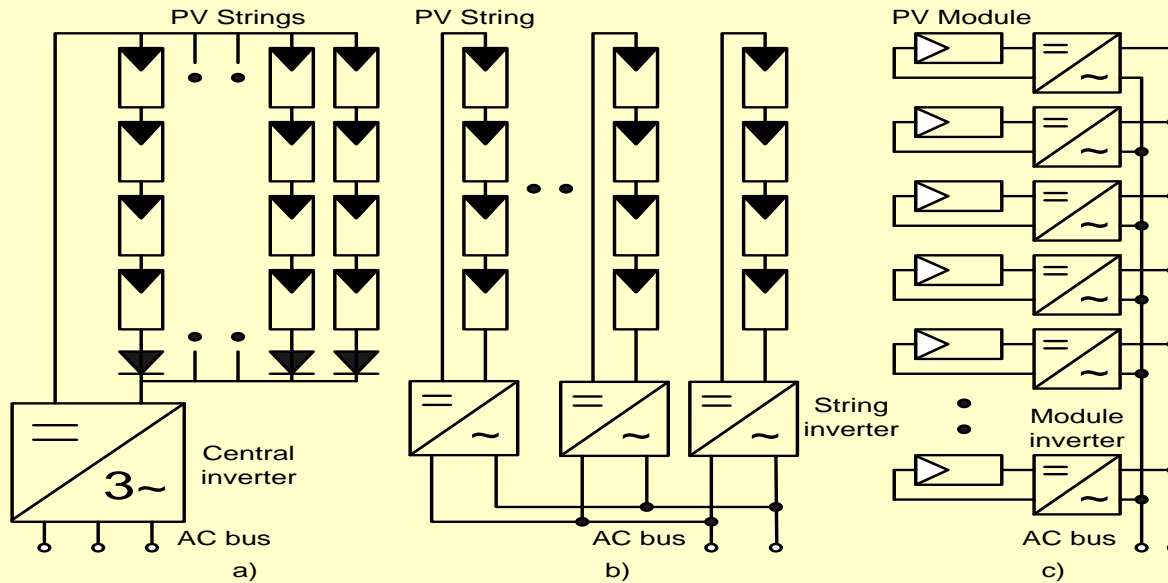
# PV Systems Configurations

## Central inverters

- 10 kW-250kW, three-phase, several strings in parallel
- High efficiency, low cost, low reliability, not optimal MPPT
- Used for power plants

## String (Multi)inverters

- 1.5-5 kW, typical residential application
- Each string has its own inverter enabling better MPPT
- The strings can have different orientations
- Three-phase inverters for power < 5kW

## Module inverters

- 50-180W, each panel has its own inverter enabling optimal MPPT
- Lower efficiency, difficult maintenance
- Higher cost/kWp

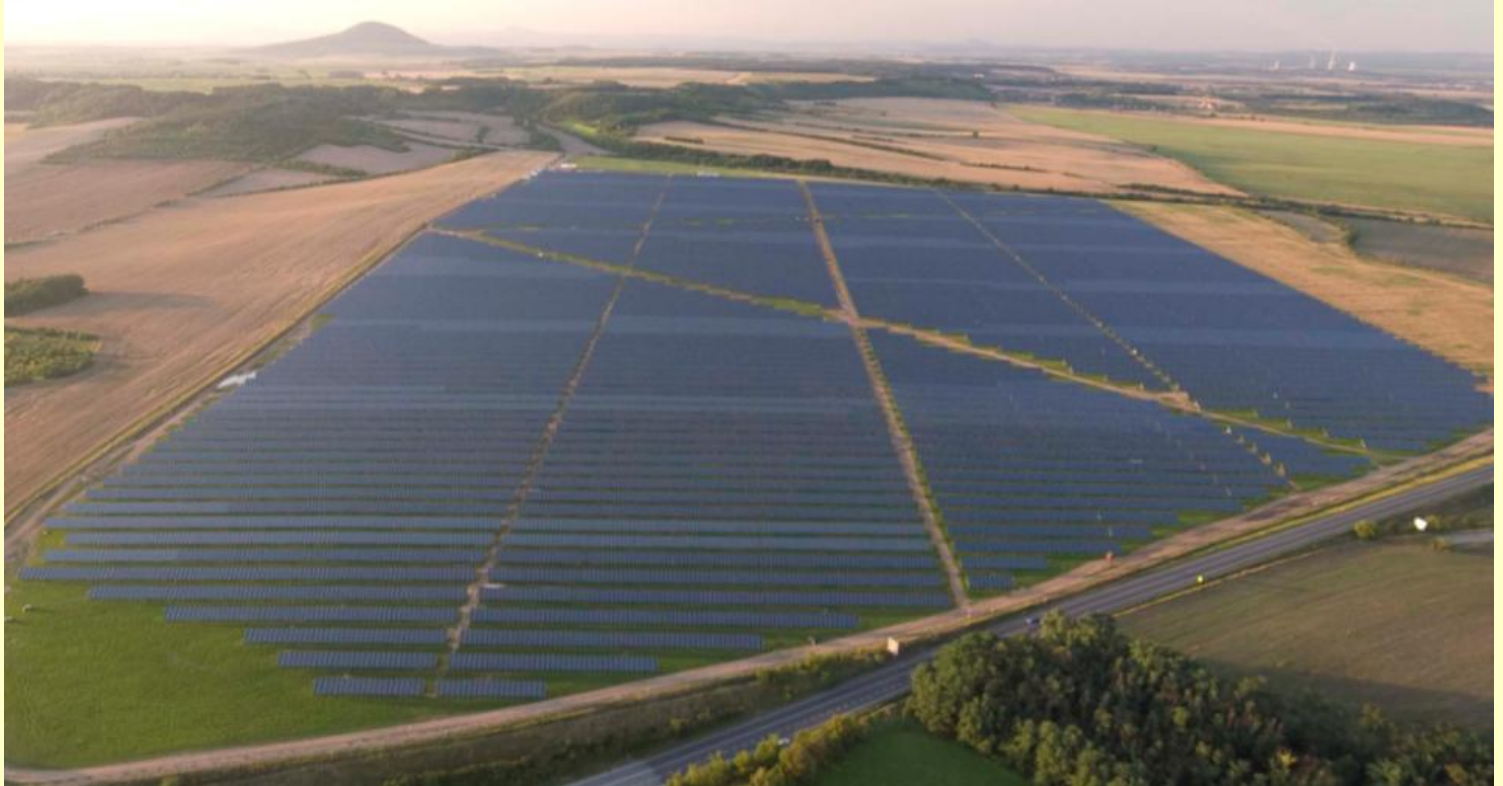
## 35 MW<sub>p</sub> power station in Veprek (20 km from Prague)

- 186 960 panels rated at 185W<sub>p</sub> and 190W<sub>p</sub> each (Phonosolar)
- 3300 SMA 10 kW and 11 kW inverters using a (multi)string configuration
- 26 transformers from 0.4kV to 22kV
- 1 transformer connects the total generated power to the 110 kV high voltage power line

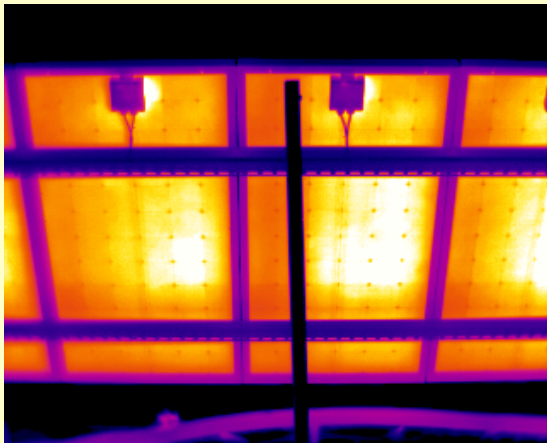
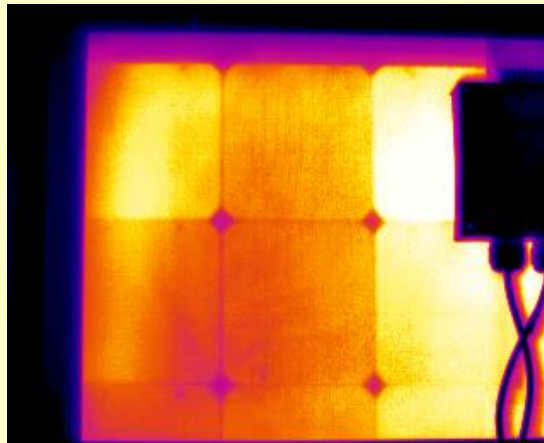
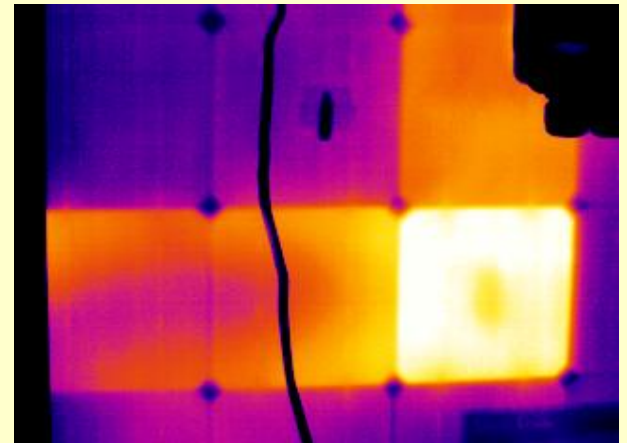
## E) check the temperature distribution

- under load over the modules can be evaluated using IR camera
- "Hot spot" appears together with the presence of local shading or when a single cell is cracked/damaged

Problematic parts of the PV system can be detected

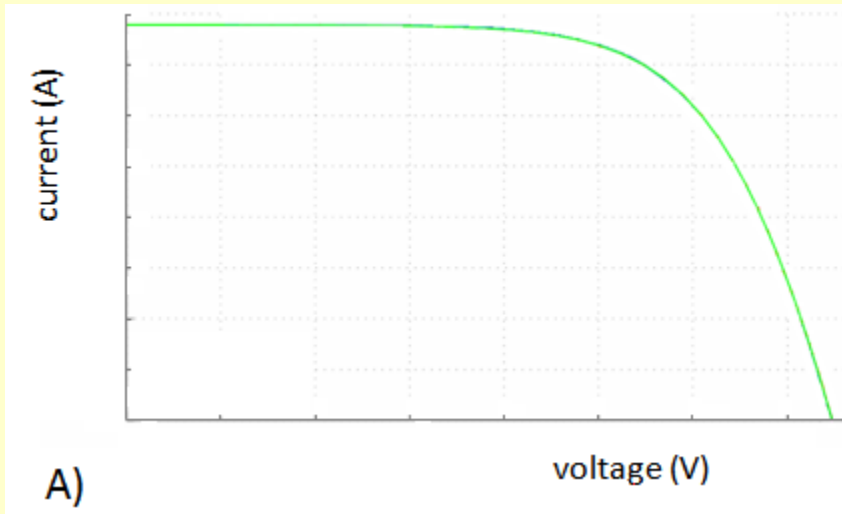
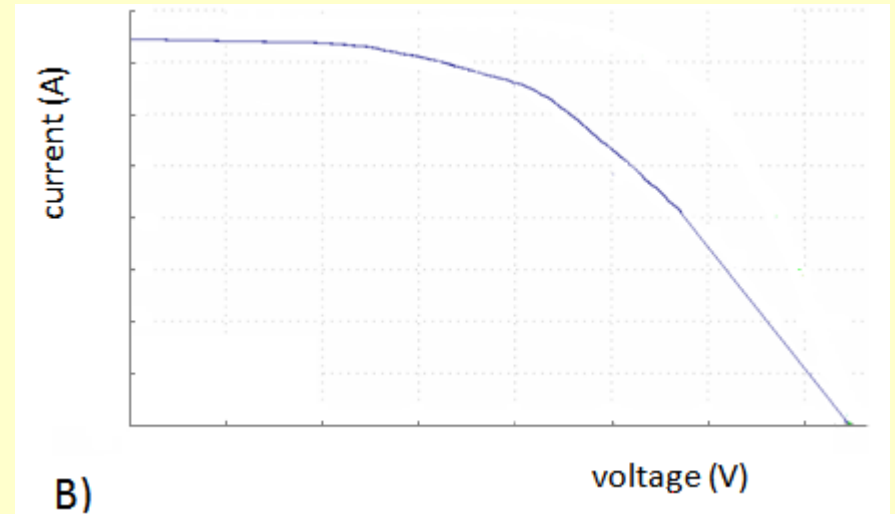
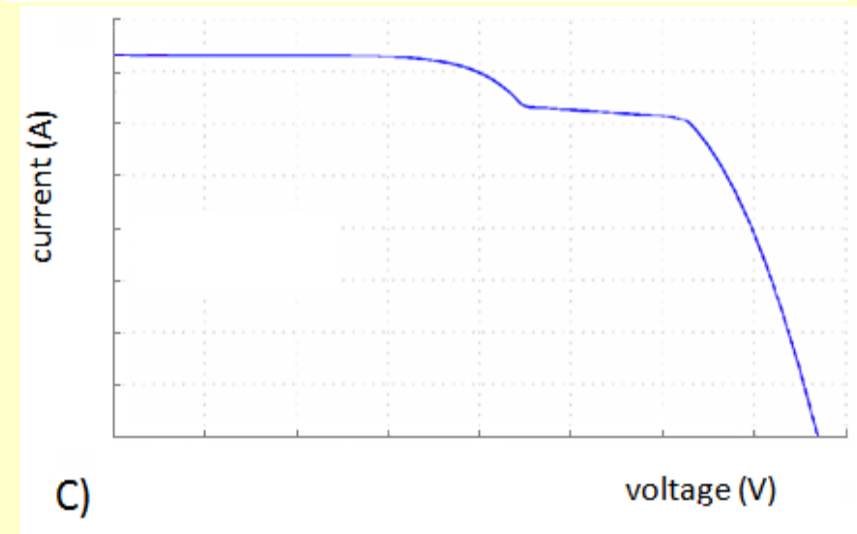
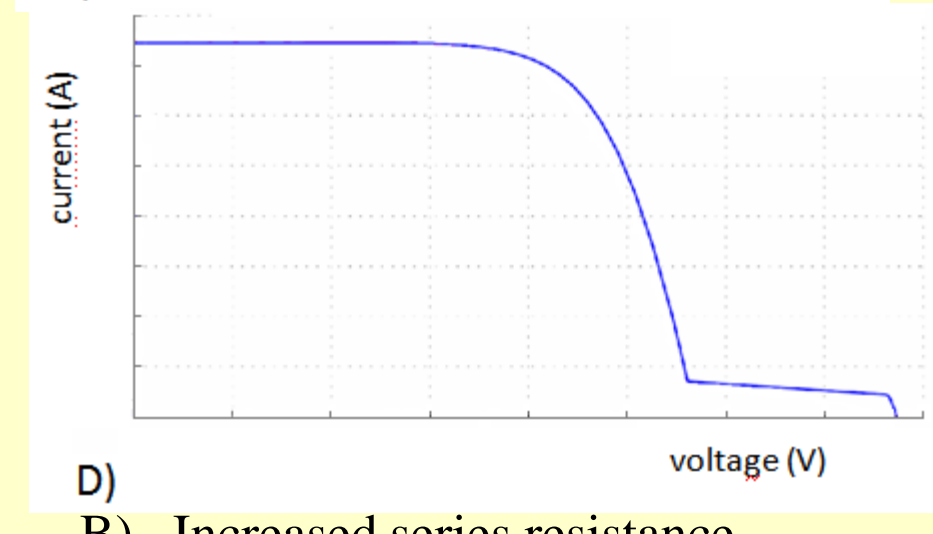
## F) checking the I-V characteristic

- A) Common I-V curve characteristics
- C) Cracked or partially shaded cell

- B) Increased series resistance
- D) Interrupted chain of cells or completely shaded cell

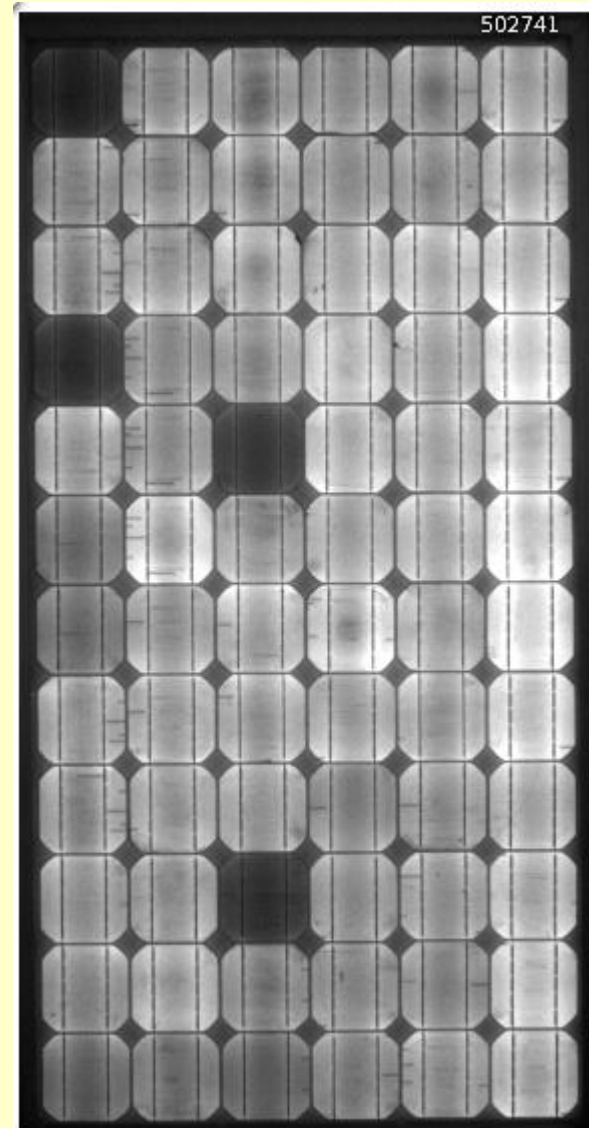
Electroluminisce

In the case of modules may  
be done more detail analyses
