Diagnostics of photovoltaic power plants operation

Vitezslav Benda,

CTU Prague, Faculty of Electrical Engineering

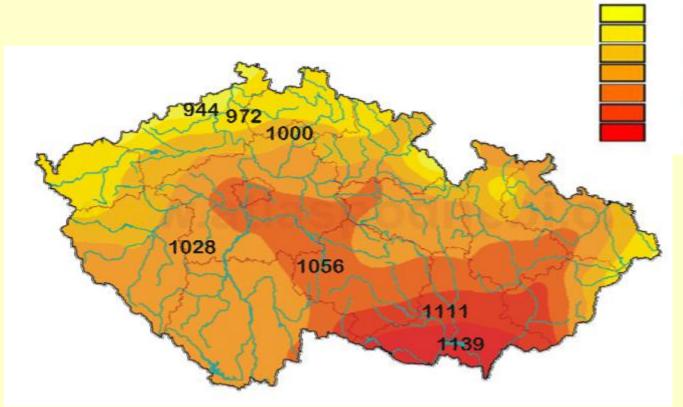
945 - 972 kWh/m² 973 - 1000 kWh/m² 1001 - 1027 kWh/m² 1028 - 1055 kWh/m² 1056 - 1083 kWh/m² 1084 - 1111 kWh/m² 1112 - 1139 kWh/m² The total output power of solar power plants in the Czech Republic

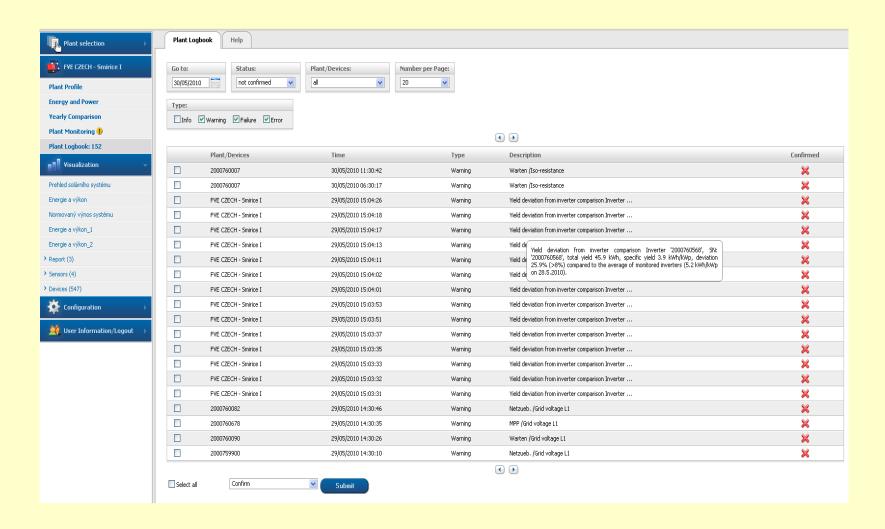
- shows the performance of all inverters
- the problem is localized if a power loss appears on one inverter (relative to an average performance of all of the inverters)
- Comparison of normalized inverter yields for 23.11.2009 brings following detailed data:

- Inverter '2000760653'

SN: 2000760653

Generator: 11,9 kWp Total yield: 20,97 kWh

Specific yield: 1,76 kWh/kWp

deviation >8% (8,7%)

The exact localization of a problem could be found under "Plant Logbook" on "Sunny Portal" (www.sunnyportal.com)

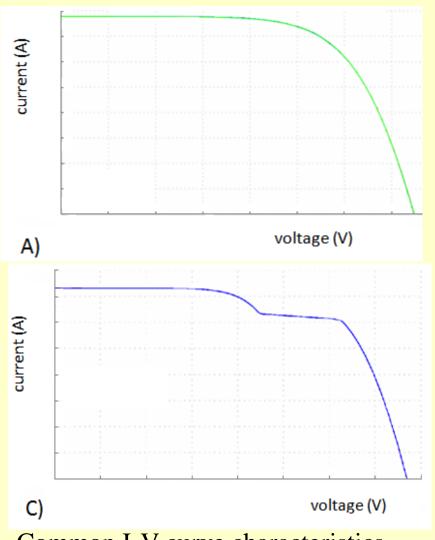
F) checking the I-V characteristic

- A) Common I-V curve characteristics
- C) Cracked or partially shaded cell

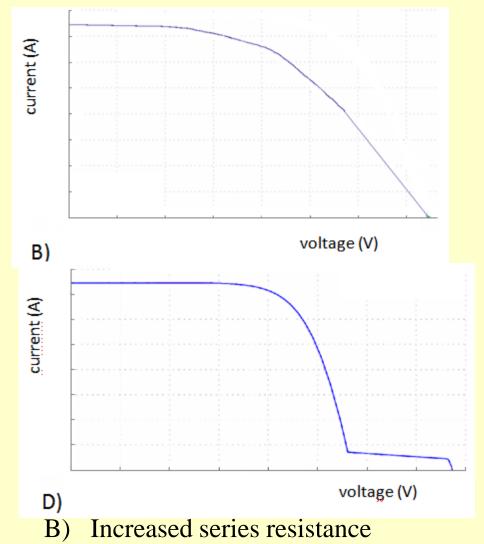
D) Interrupted chain of cells or

completely shaded cell
